XM heater flap servo

Problems with the servo motor unit that moves the heater flap seems to be quite common on (older) XM's.

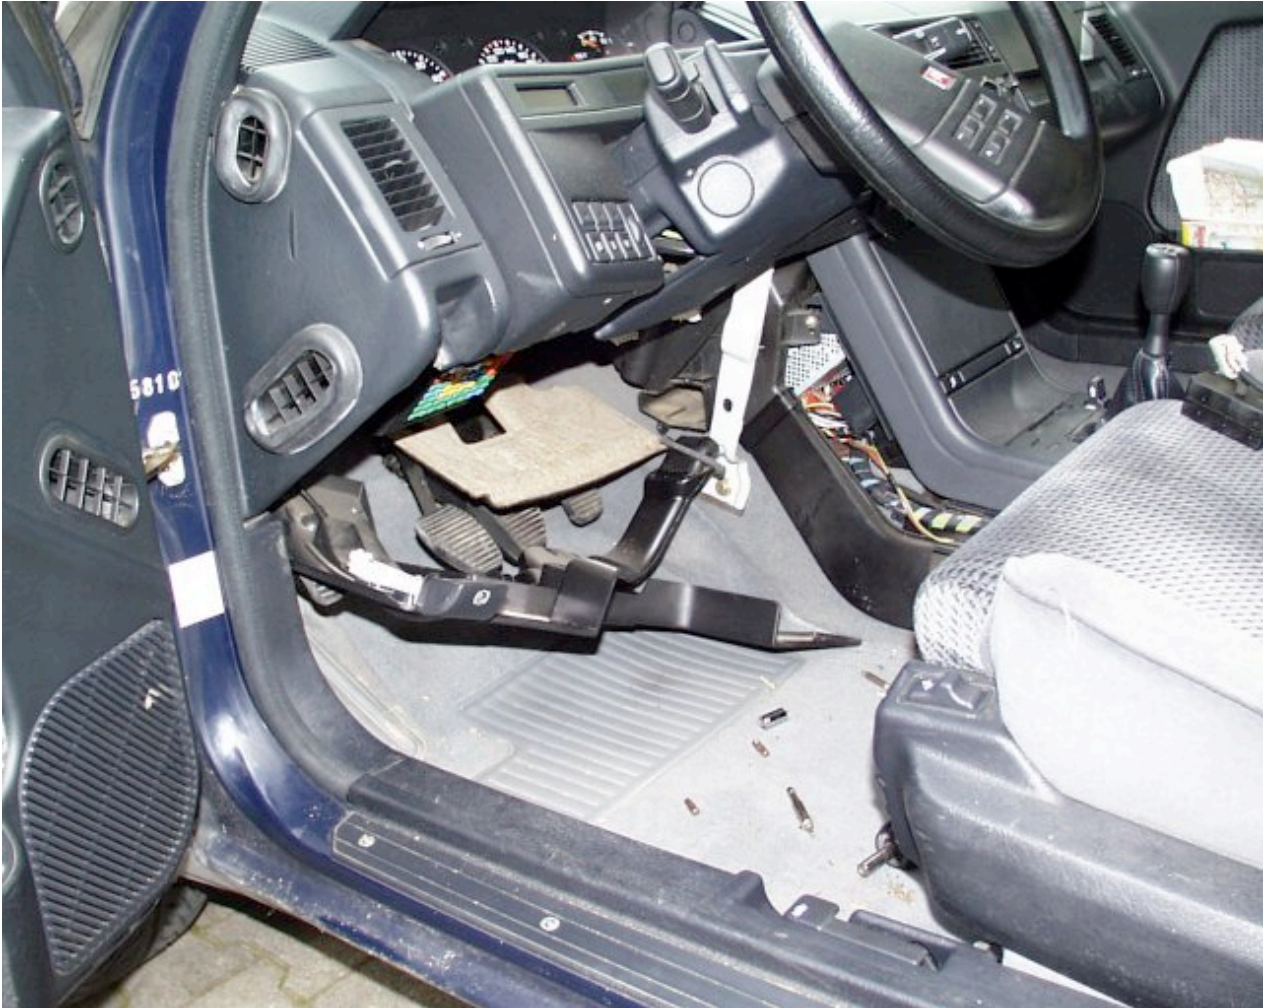
The heater flap servo is located on the left side of the central heater box high-up under (in) the dash. In order to be able to remove the servo from the car, the panel under the steering wheel has to be removed first (see Fig. 1). One also has to remove the carpet covered panel in the footwell that cover the left side of the central console.

Fig. 1 : Panel under the steering wheel and carpet covered panel removed.

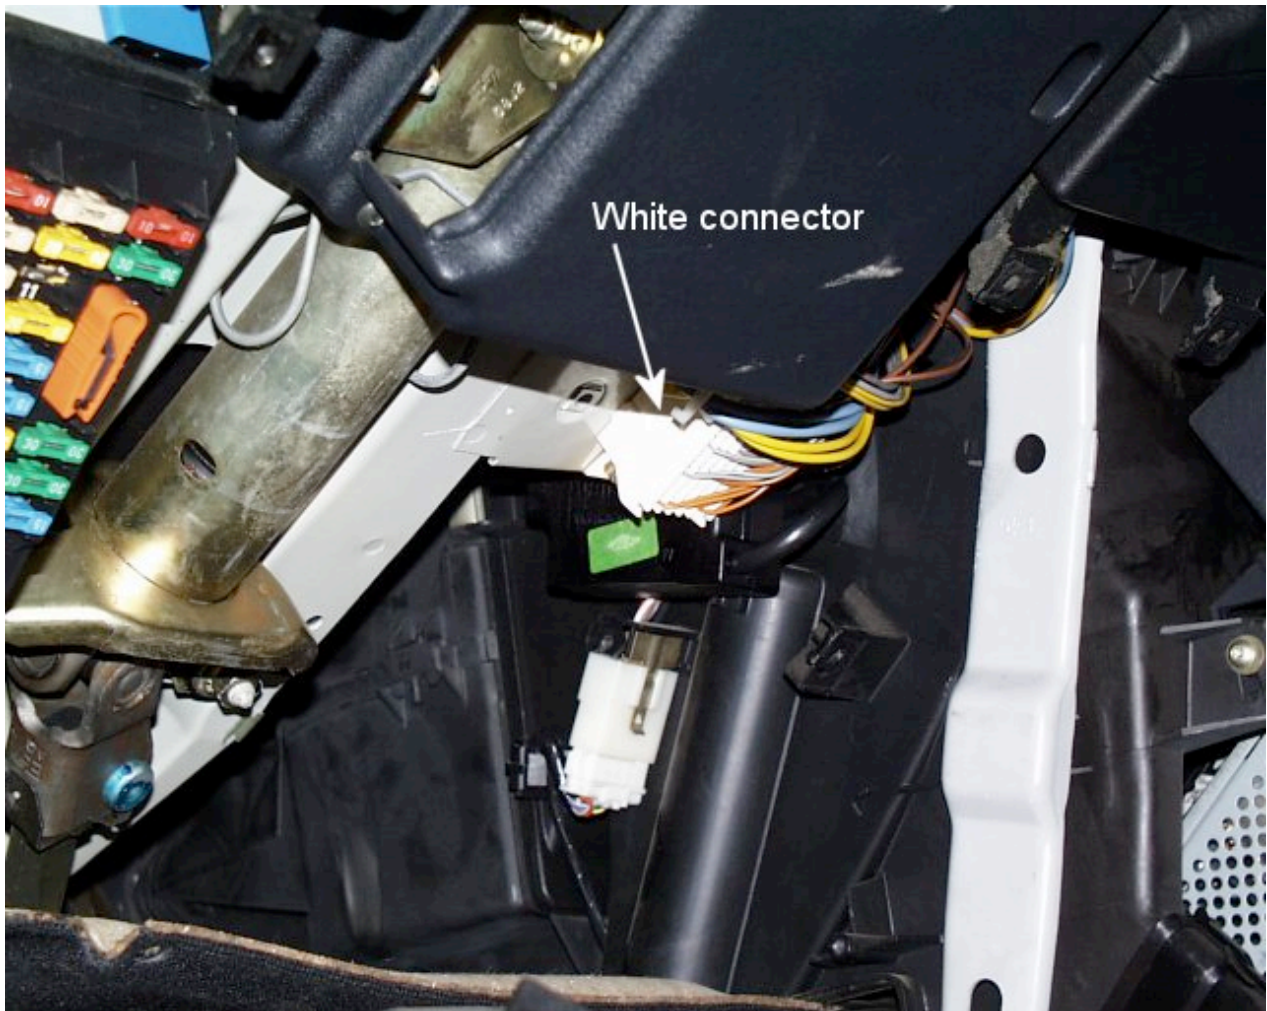
When the panels have been removed the flap motor servo unit is visible under the dash. Unfortunately the front screw that mounts the servo to the heater box can not be accessed because of the of large white connector (See Fig. 2 and 3). The rear screw is not visible at all, here a very short screwdriver is needed because of the limited space.

Fig. 2 : The heater flap servo is now visible, it's small black plastic box with the green sticker.

The white connector has to be removed in order to be able to access the front screw. The connector is bolted to the frame with two bolts, removing is easy.

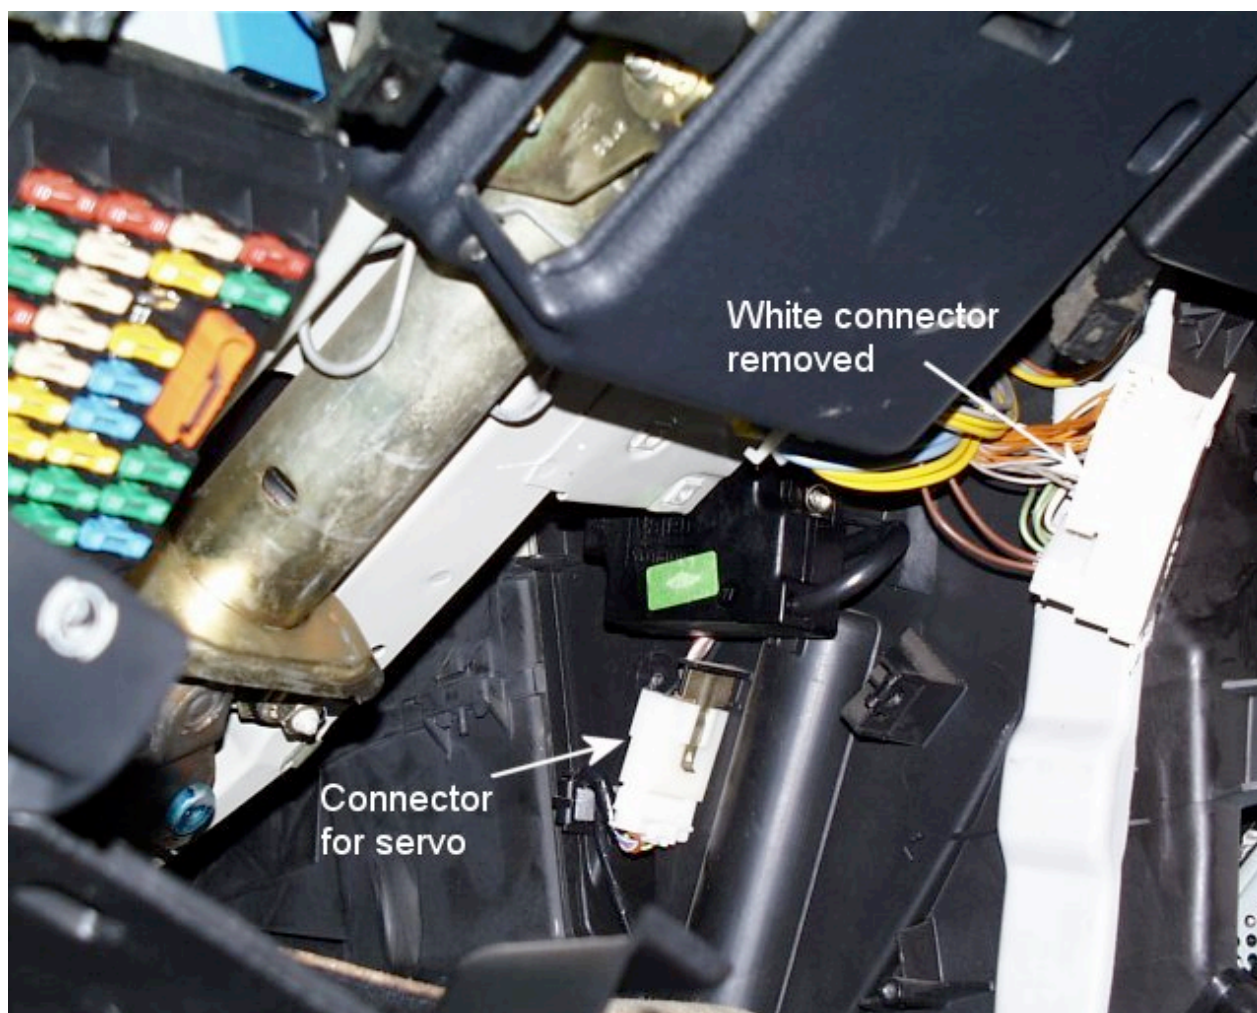
Fig. 3 : After removing the white electrical connector unit the rear mounting screw is accessible.

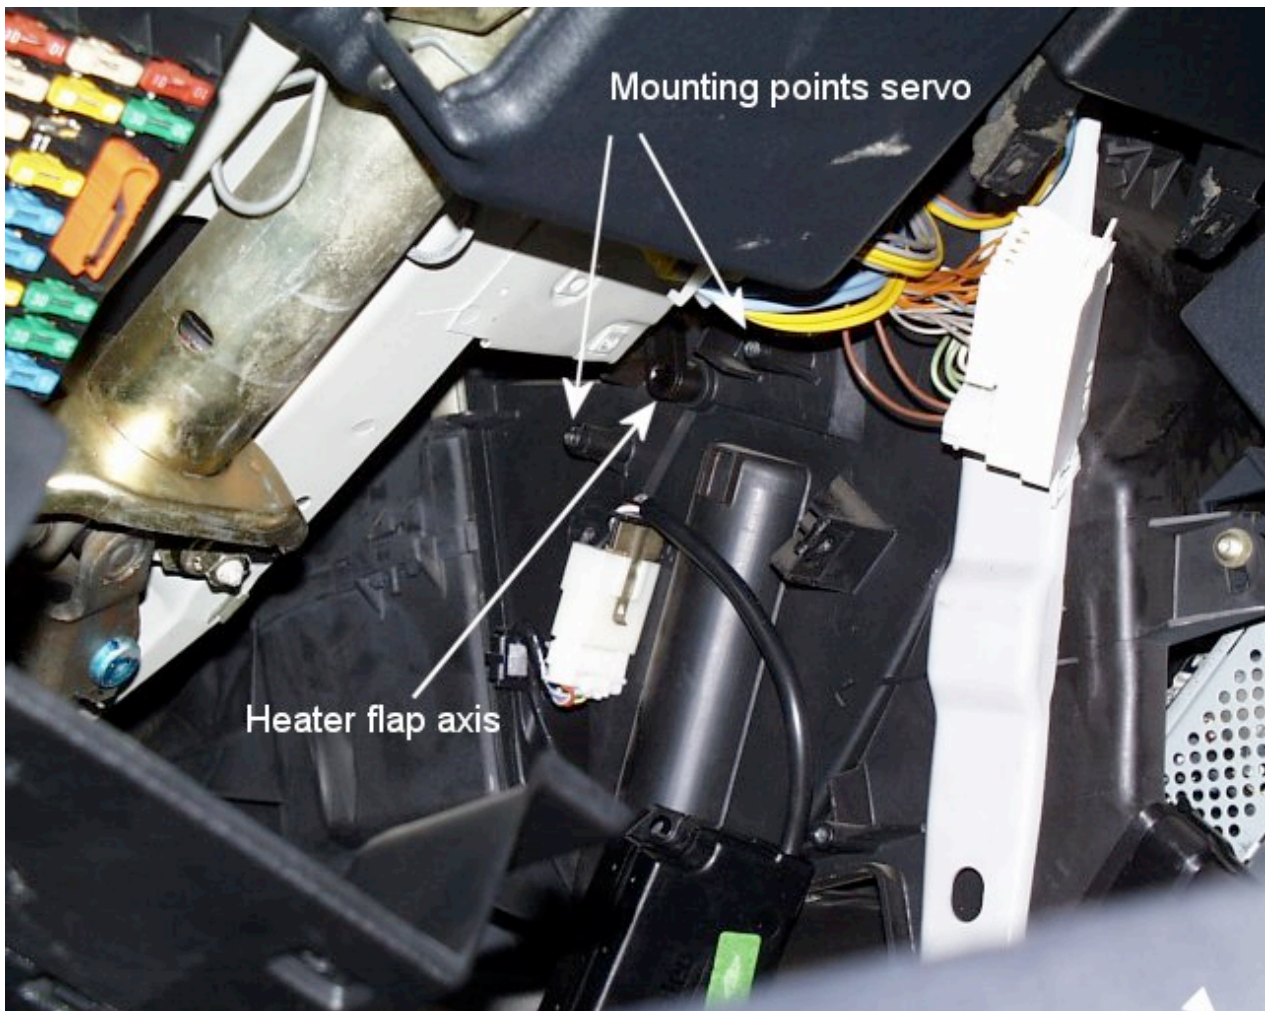
After the heater flap servo has been removed (Fig. 4) one can see the two mounting points and the heater flap axis with the small lever-arm (which is probably there for the cars with manual heater control).

Fig. 4 : The servo is now removed, it's hanging from its electric cable.

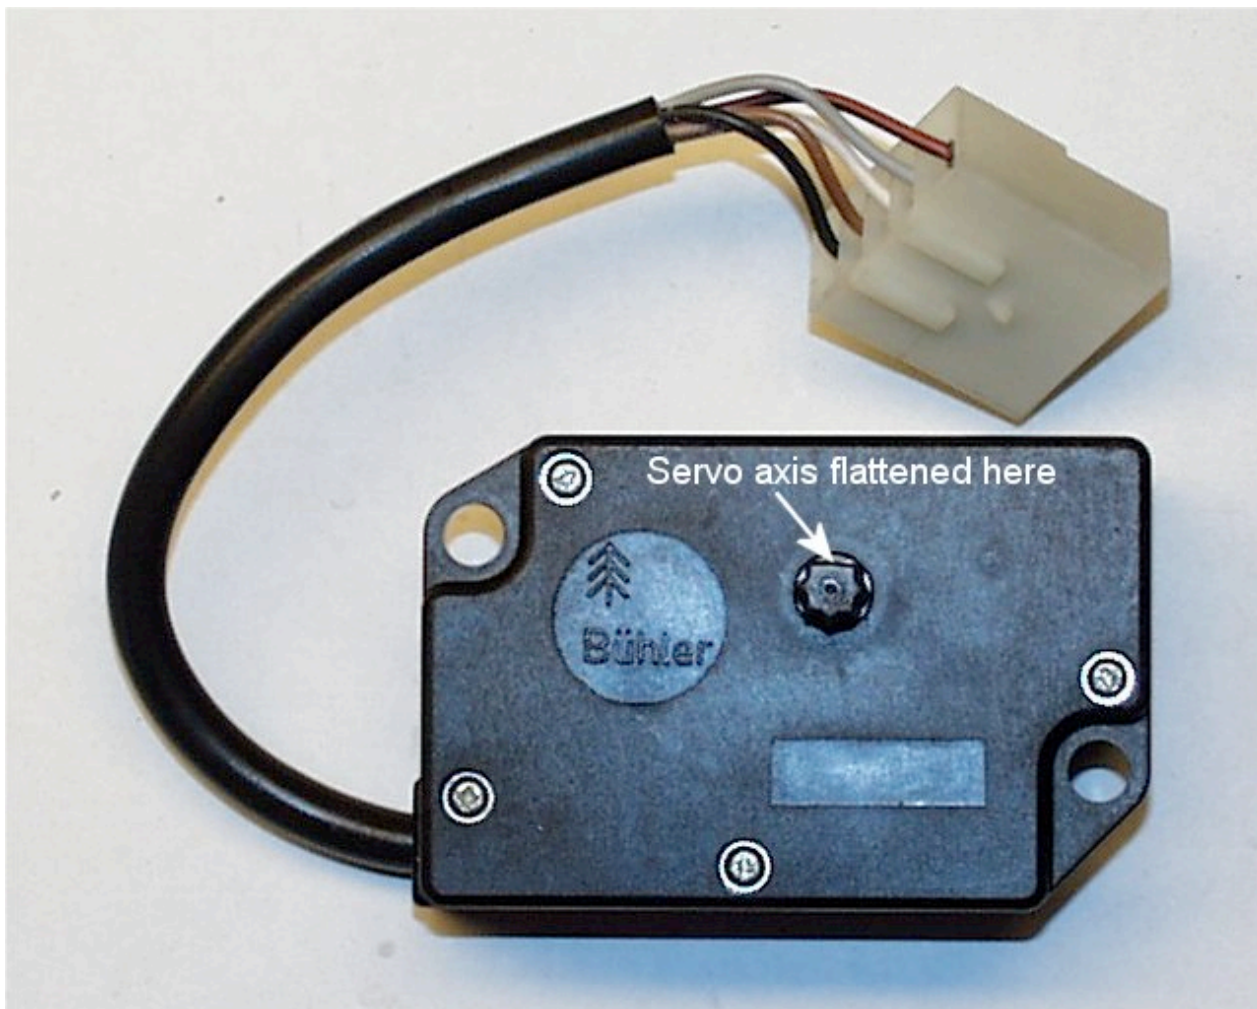
The servo axis is flattened at one side (see Fig. 5), the hole in the heater flap axis has the same shape. Both axis will fit together at one position only, so make sure that the servo axis is in the same position after reassembling.

Fig. 5 : The complete heater flap servo.

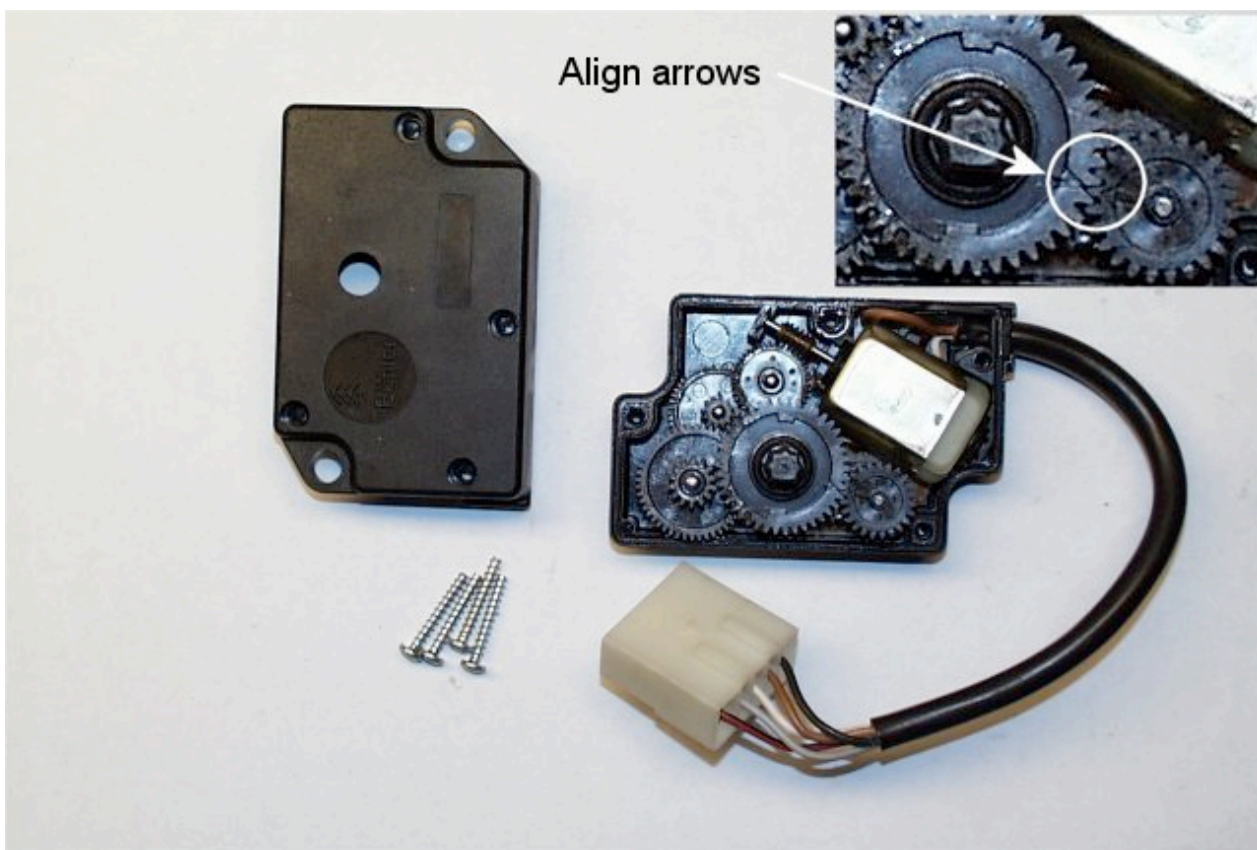
The servo is easily opened by unscrewing the four screws (see Fig. 6). Take care while pulling apart the two halves of the servo box in order not to tear the rather fragile seal (see Fig. 7). Please note the arrows on the big gear wheel (that drives the flap) and the smaller gear wheel (that drives the servo potentiometer) at the right. On both gear wheels there is an arrow, they have to be aligned when the servo is reassembled.

Fig. 6 : The heater flap servo box opened.

Assemble the rotor in the motor outside and dry-run it first with a 9V battery. If it works you can reassemble it back in the flap control housing. When assembling look at the marking on two of the gear-wheels they should face each-other getting the potentiometer in line with the flap position.

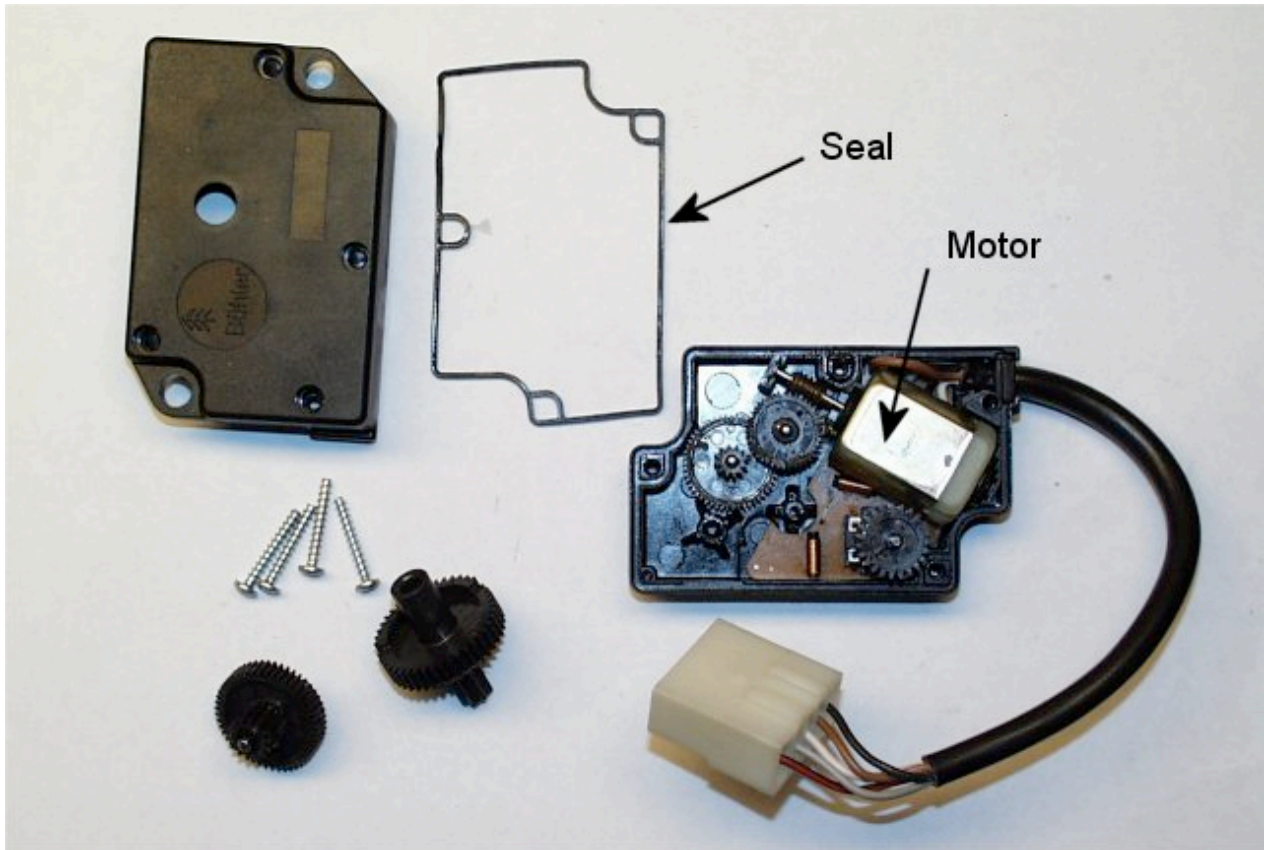
The two gear wheels mentioned above are easily removed (just pull them upwards).

Fig. 7 : The heater flap servo partly disassembled.

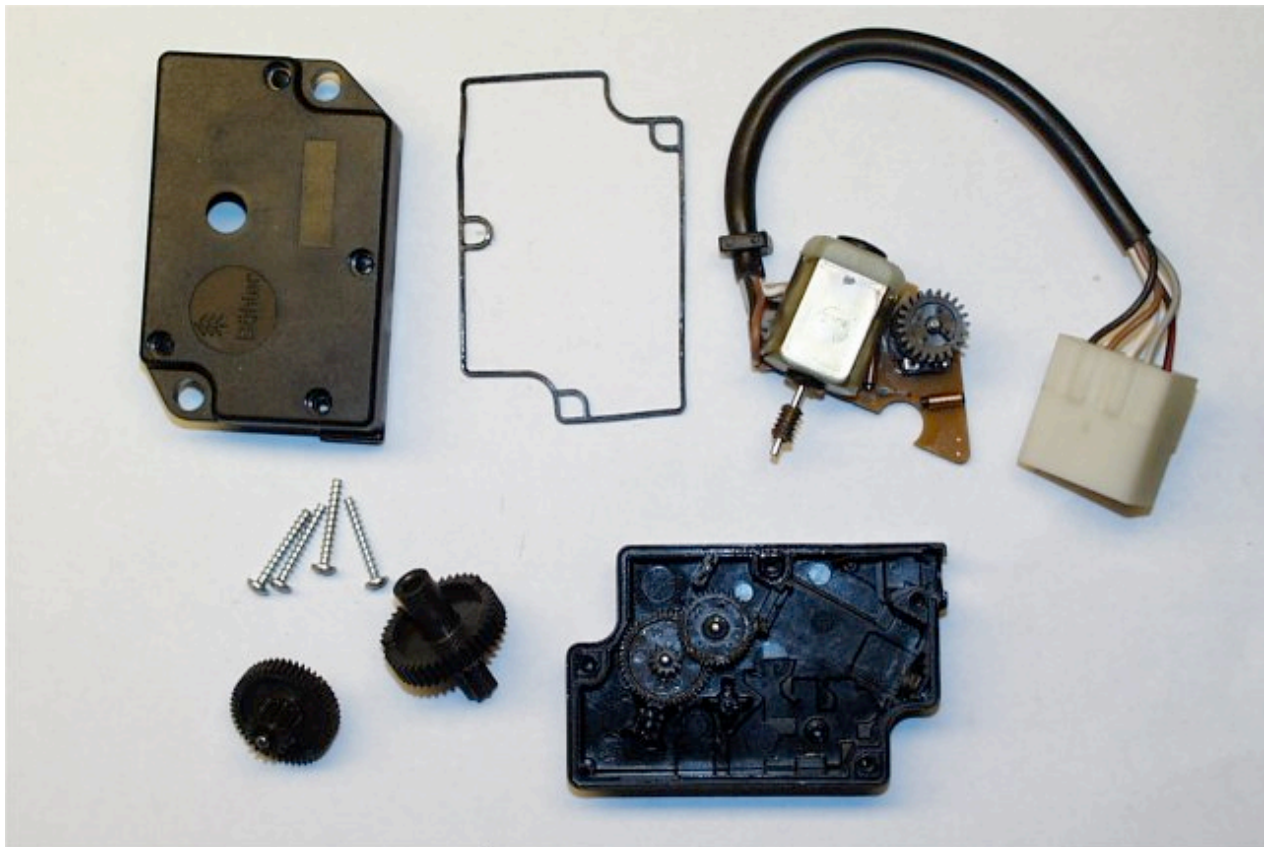
Now the little motor can be removed together with the circuit board (PCB). The motor is soldered onto the PCB.

Fig. 8 : The heater flap servo almost completely disassembled.

The motor can be tested by applying 7 Volt DC to the brown and the black wire in the plug. Of course you can also do this when the servo is still assembled.

Typically what happens is that the brushes in the motor short circuit a little, so the current through the motor is to big for the IC output in the climate control ecu to handle. I took me some time to figure out, because in my case the motor would still run on a normal 9V battery (and then it runs for some time until the motor stops at the wrong place causing the brushes to short-circuit again.) If above sounds familiar than read on below.

It's not that difficult to solve if you are careful and handy. You can open up the unit and solder the motor out. Don't overheat it with the soldering iron btw, I did that the first time and the plastic where the brushes are in melted a little.

If you have the motor apart you can carefully scrape the brushes of the motor somewhat into shape. You must scrape some of the graphite(?) off, so the brush is more square rather than rounded around the contacts of the rotor (which is causing the short-circuit).
